# BRESKIN POND DAM No. 1

## PHASE I INSPECTION REPORT NATIONAL DAM INSPECTION PROGRAM

**MICHAEL BAKER, JR., INC.**  
Consulting Engineers  
4301 Dutch Ridge Road  
Beaver, Pennsylvania 15009

Breskin Pond Dam No. 1, Westmoreland County, Pennsylvania  
NDI No. PA 01141, PennDER No. 65-141  
Unnamed Tributary to Fourmile Run  
Inspected 5 December 1980

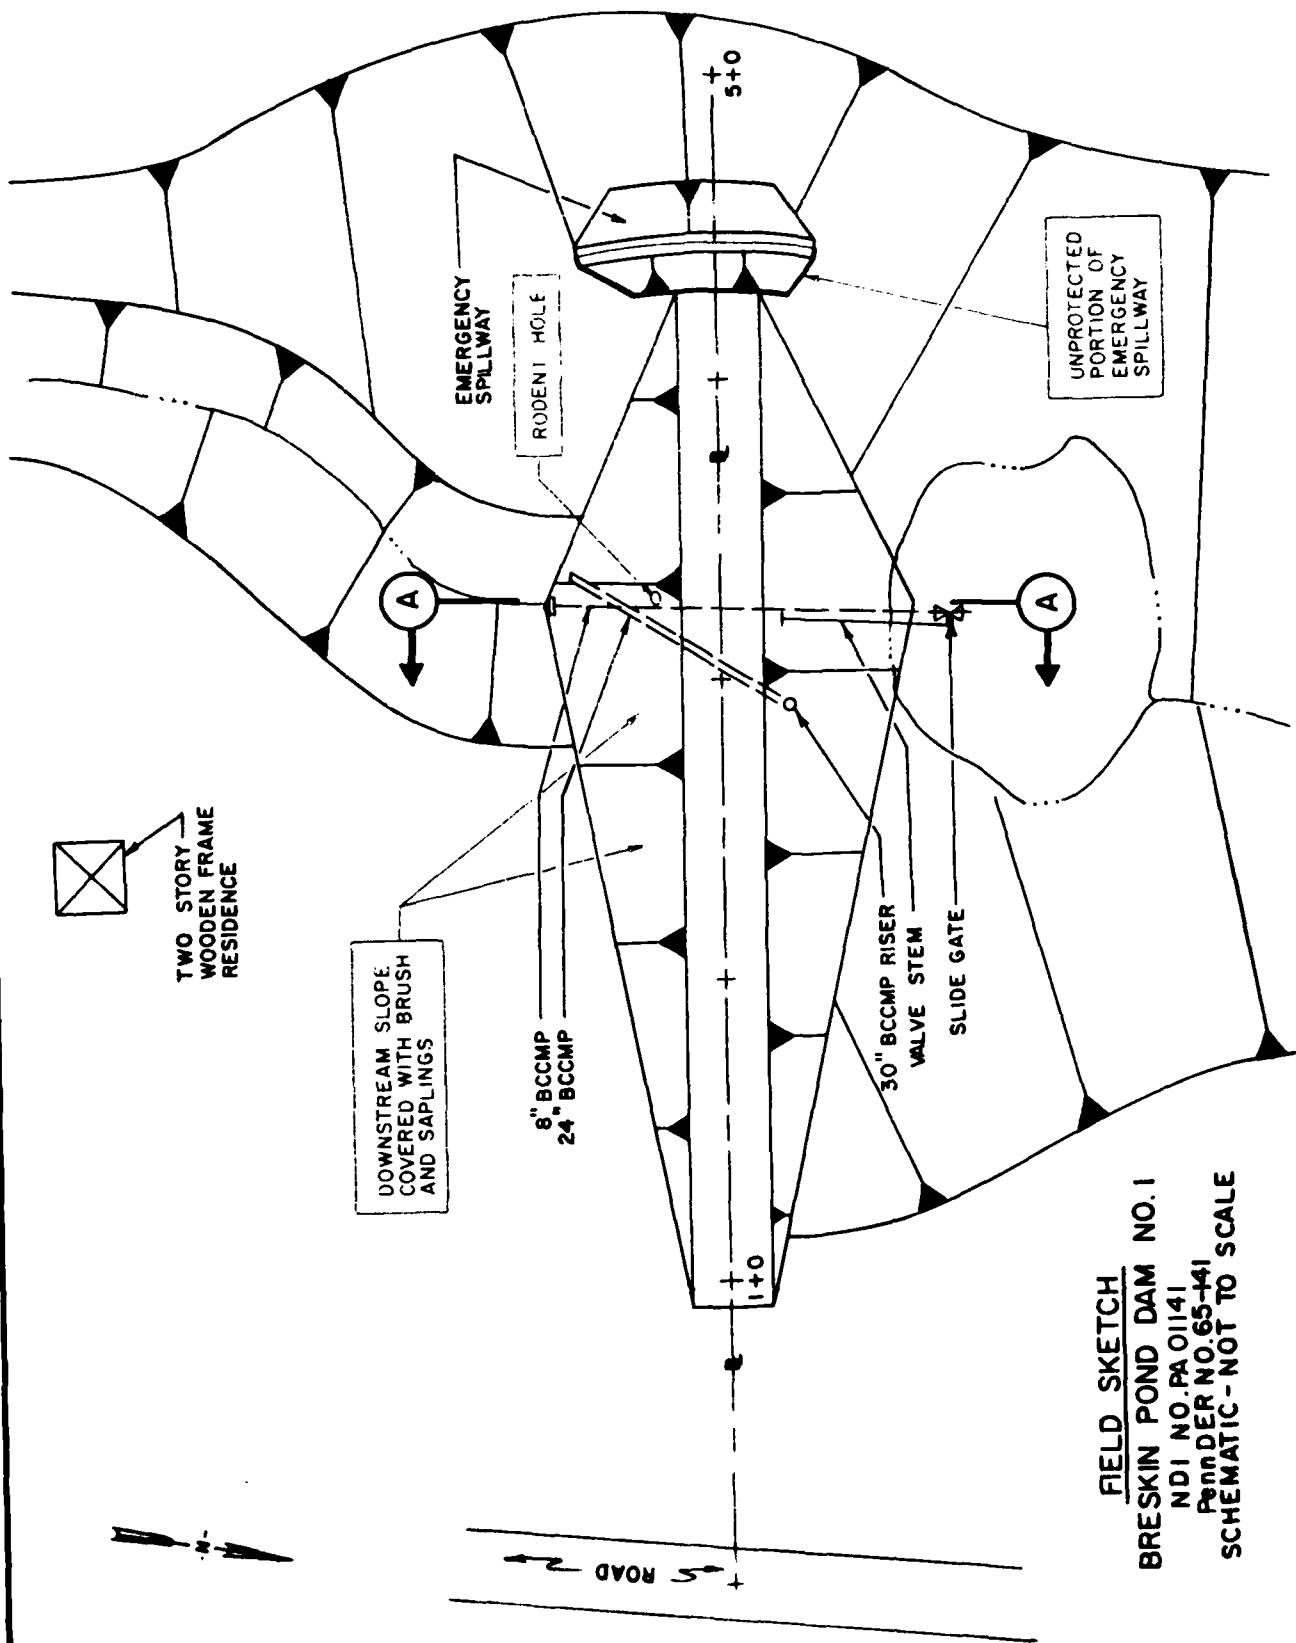
FIELD SKETCH  
 BRESKIN POND DAM NO. 1  
 NDI NO. PA 01141  
 PENDER NO. 65-41  
 SCHEMATIC - NOT TO SCALE

ANIMAL/RODENT HOLESA rodent hole was observed at  
approximate station 3+25, approx-  
imately 7 ft. below the crest.
